Technical Paper

Overcoming Common Wax Injection Problems: The First Step toward Automation

Aaron Phipps
VP of Sales and Marketing
Technology Center Manager
MPI, Inc.

Jeffrey Rich
VP of Operations
MPI, Inc.

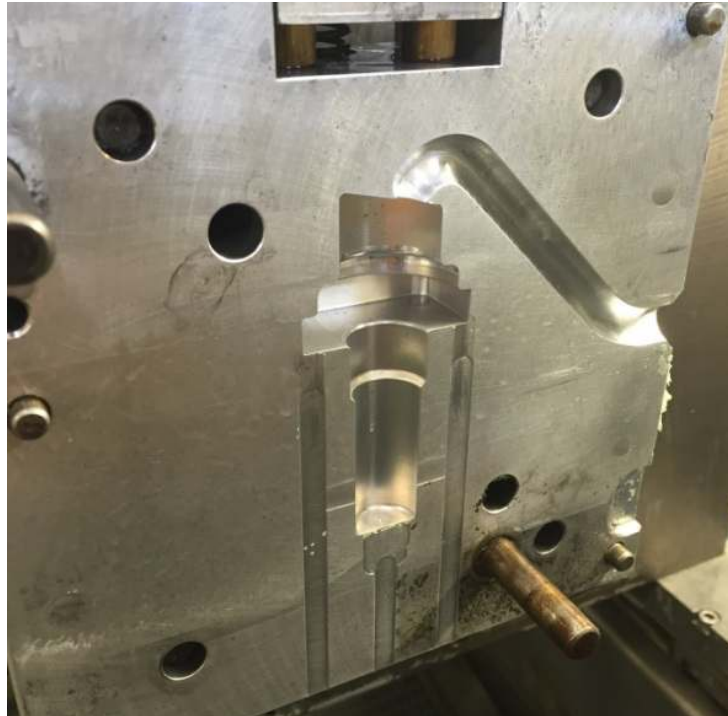
Figure 1: Die

The test die is capable of running on a horizontal automatic press. It is a standard two-piece die with ejection pins allowing the part to fall out of the die into a water bath. It contains one slide block that make four holes in the part. The die typically produced between 45 and 55% defective parts. No data was captured on the quantity of parts that could be used with some repair. Defective parts were mostly just remelted for another injection. The process was largely untended on the automatic press, but was time consuming due to the requirement to inspect every part. While the part produced a variety of defects, by far the most common was entrapped air.

The die was examined to see if any possible causes could be determined for this effect. The injection runner with a diameter of $\frac{3}{8}$ inch was necked down to $\frac{1}{4}$ inch just prior to entering the die cavity. The necked down portion of the runner is visible in the die picture figure 1. Figure 7 shows more clearly the resulting pattern from the necked down runner. It was hypothesized that this minor change in the wax's flow path was contributing to the observed condition causing the high defect rate. It is common practice to neck down a runner or gate to allow for easier separation of the runner and/or gate in either wax or metal. That practice may contribute to

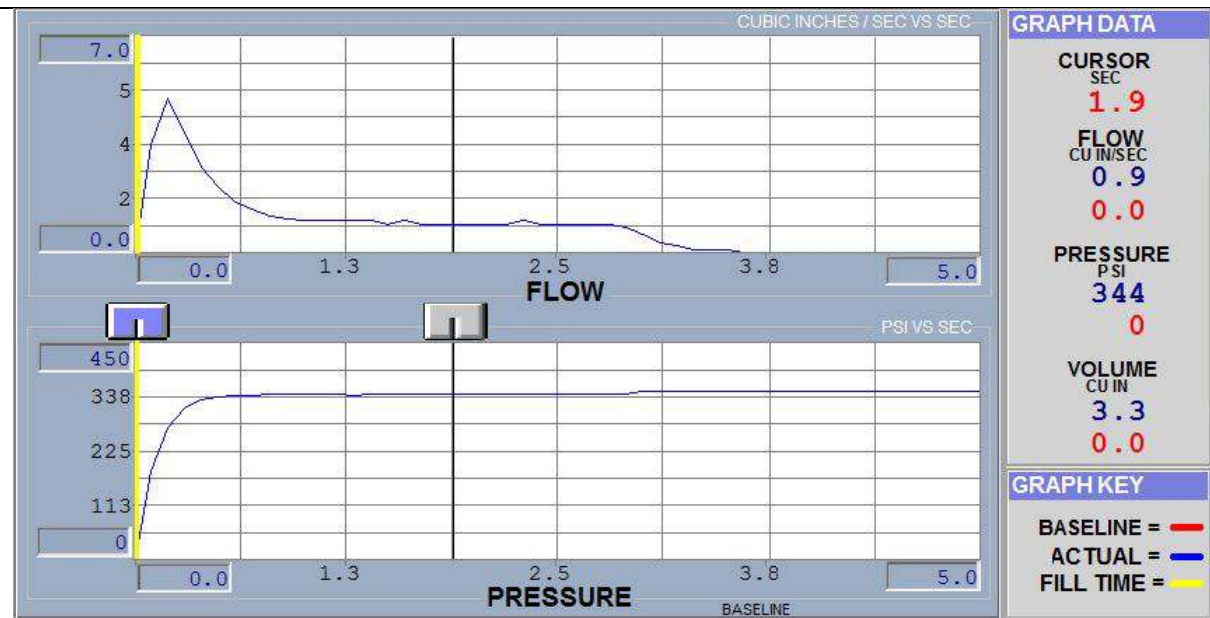
Figure 3: Flow and pressure graphs for Pre-optimization injections – Note flow set point was 13in^3

The blue line in the graphs contained in figure 3 represent the actual flow (top graph) and pressure (bottom graph). This is a classic example of a machine set up incorrectly. The machine is operating in a “pressure limited flow” state. That condition exists when the set point of the pressure, which was 350psi and was achieved, is inadequate to reach the set point of the flow, 13in^3 . Looking at the graphs you can see the machine initially tried to achieve the flow rate reaching a high point nearly 5in^3 momentarily and then dropping to a steady state rate of 1in^3 with the pressure at the maximum available for the injection, 350psi (based on set point). An appropriately set up machine would have the pressure set to a value that allows the desired flow to be achieved and also provides the correct pack pressure for the die once the cavity is full. When the pressure is adequate to achieve the desired flow the machine is in “flow control”. The first step in optimizing the die was to get the machine in flow control.

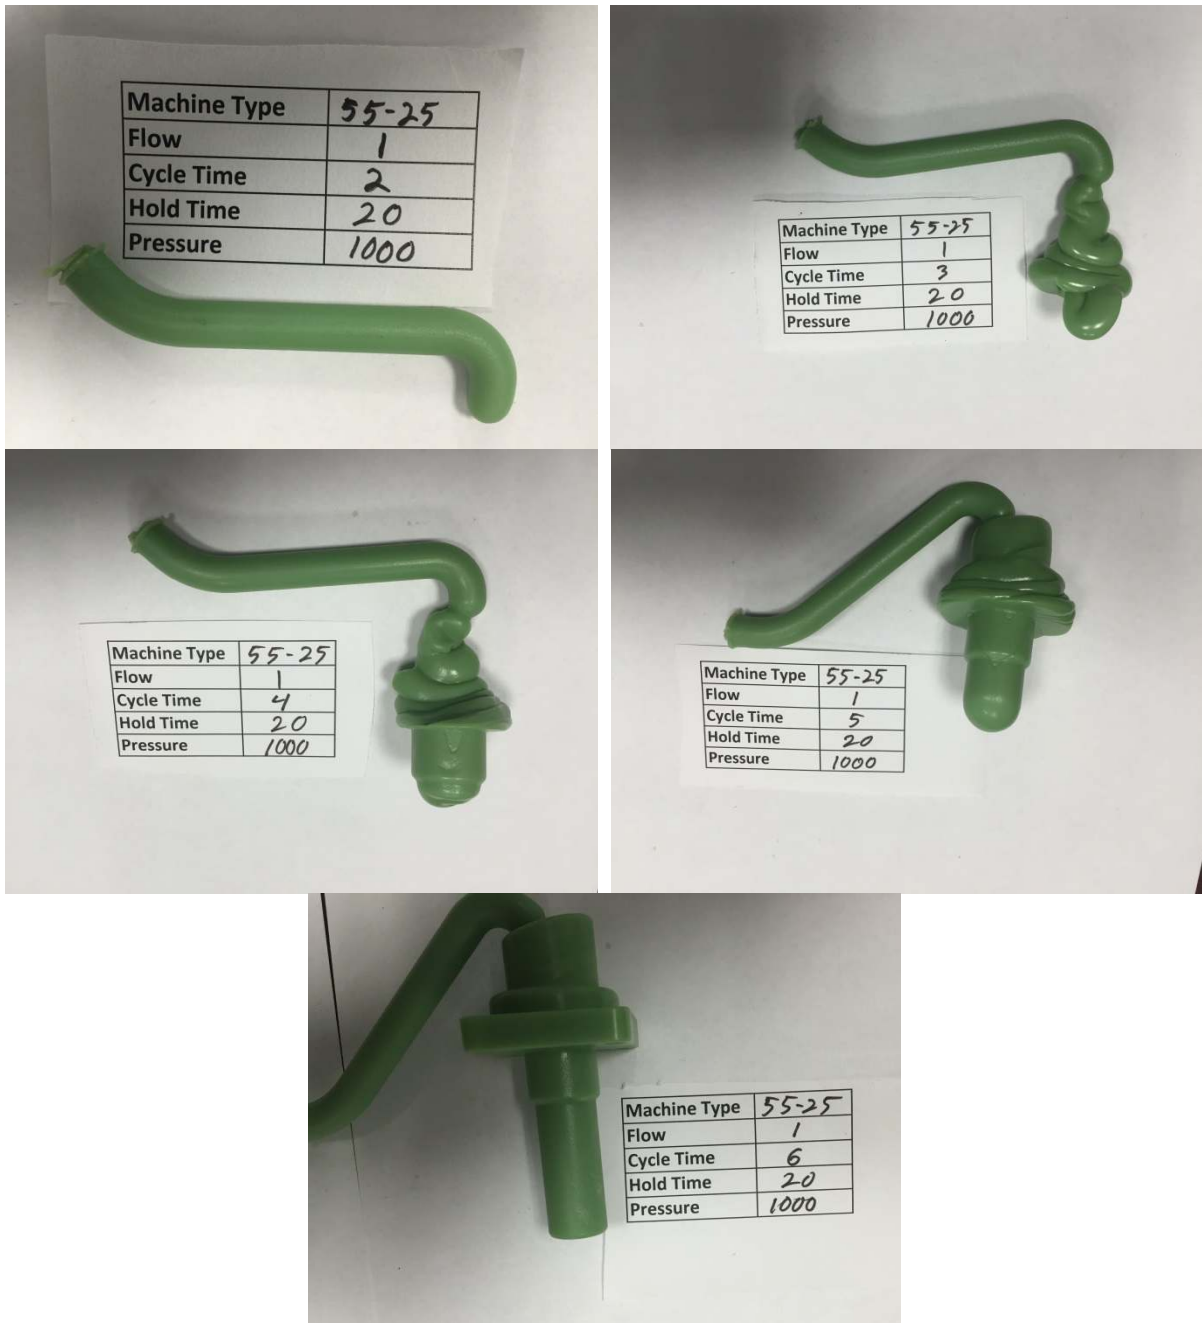
Figure 6: Sample of Short Shot picture Series

Careful examination of the short shot pictures combined with an understanding of the geometry of the die cavity and specifically the injection runner led to a conclusion. The short shots showed us that the wax entered the die cavity from the injection runner and filled the cavity like a stream of spaghetti. Flowing in this manner the cavity allowed the wax to fold over itself inside the die. This folding allowed air to be entrapped between wax folds. The entrapped air in many instances was completely surrounded by wax. In those instances, the part may prove to be acceptable as no surface defects occurred. In parts where the entrapped air was very near or at the surface of the wax, the part was defective.

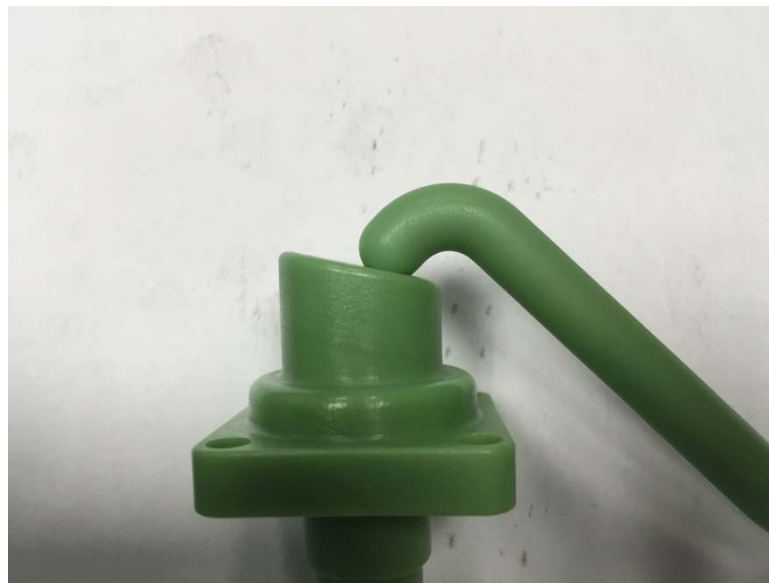
Figure 7: Picture of runner necked down

defective patterns as the wax flow through the necked down portion becomes more turbulent. The decision was made to remove the material in the necked down area allowing the wax a more laminar flow from the runner entering the wax cavity. After the die modification, further testing would be required to observe the results of this change.

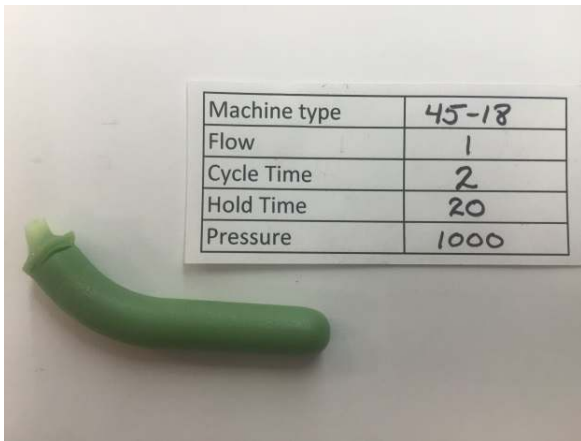
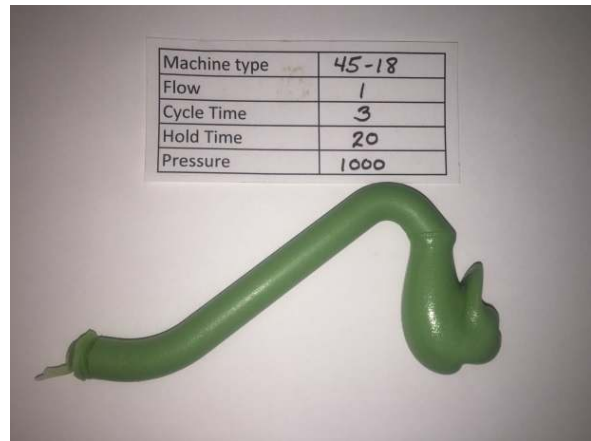
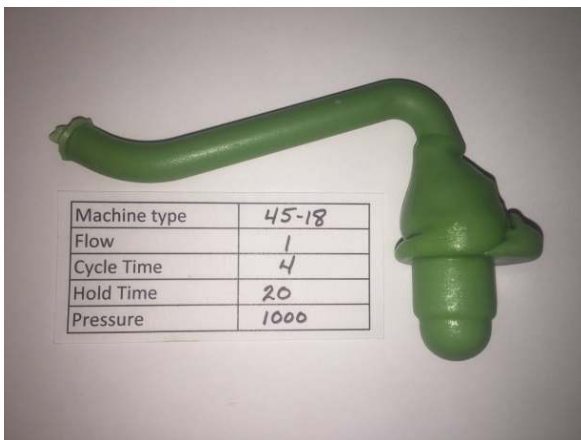
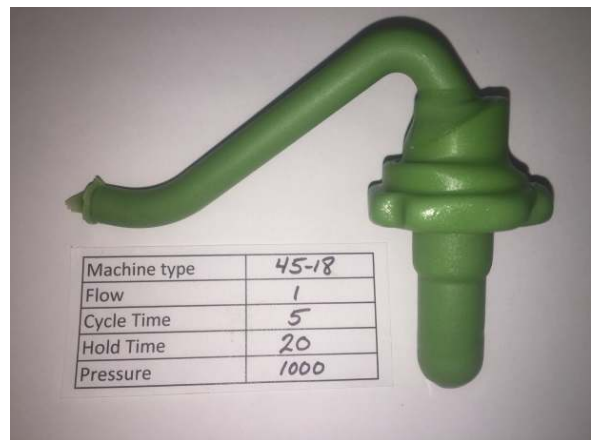
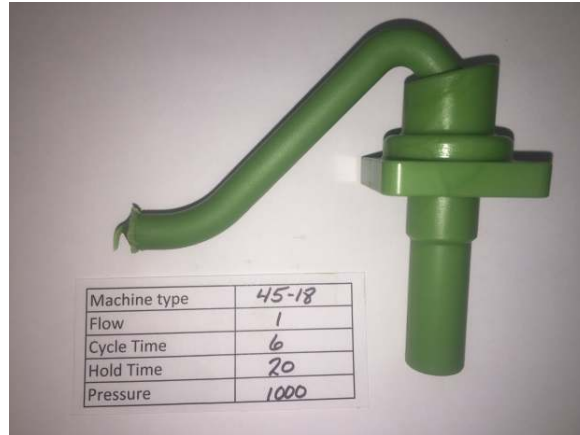
Figure 10: Sample of Short Shot picture Series Post Die Modification

The success of this experiment was evident immediately. The short shots no longer had evidence of wax folding over itself in the die cavity. As a result, entrapped air was eliminated or reduced to a level not detectable. In step two of the experiment number 3, a 40-part injection run was completed with no defective parts found. We observed consistently high quality parts being produced, thereby allowing the die to run in a fully automatic mode. With a 0% defect rate, it was decided to make an extended run. An additional 60 parts were made and one part did show a minor defect, which was repairable with minor rework, however we noted it as a defect giving us a 1% defect rate. The experiment was again run with both the low and high flow settings previously selected and the results were the same 1% defect rate.
