# Overcoming Common Wax Injection Problems: The First Step toward Automation

Featured in March 2016 Issue of InCast Magazine

Presented during the 14<sup>th</sup> World Conference in Investment Casting  
Paris, France  
April 18, 2016

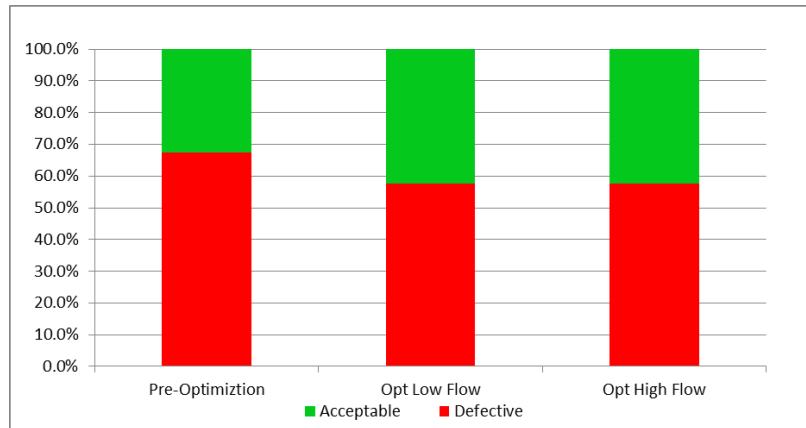
Figure 4: Defect Rate – Pre-optimization and optimized

Machine (Horizontal and Vertical Injections)			
		Optimized	
Injection Parameters:	Pre-Optimization	Low Flow	High Flow
Injection Dwell Time (seconds)	50	26	26
Wax Inj. Pressure (PSI/bar)	350/24.1	700/48.3	700/48.3
Flow (inches <sup>3</sup> /cc <sup>3</sup> per second)	13*/213*	1/16.4	4/65.5
Wax (degrees F/C)	130/54.4	130/54.4	130/54.4
Stationary Platen (degrees F/C)	70/21.1	65/18.3	65/18.3
Moving Platen (degrees F/C)	70/21.1	65/18.3	65/18.3
Injected Parts per hour **	59	99	99
Defect Rate	67.5%	57.5%	57.5%
Acceptable Parts per hour	19	37	37

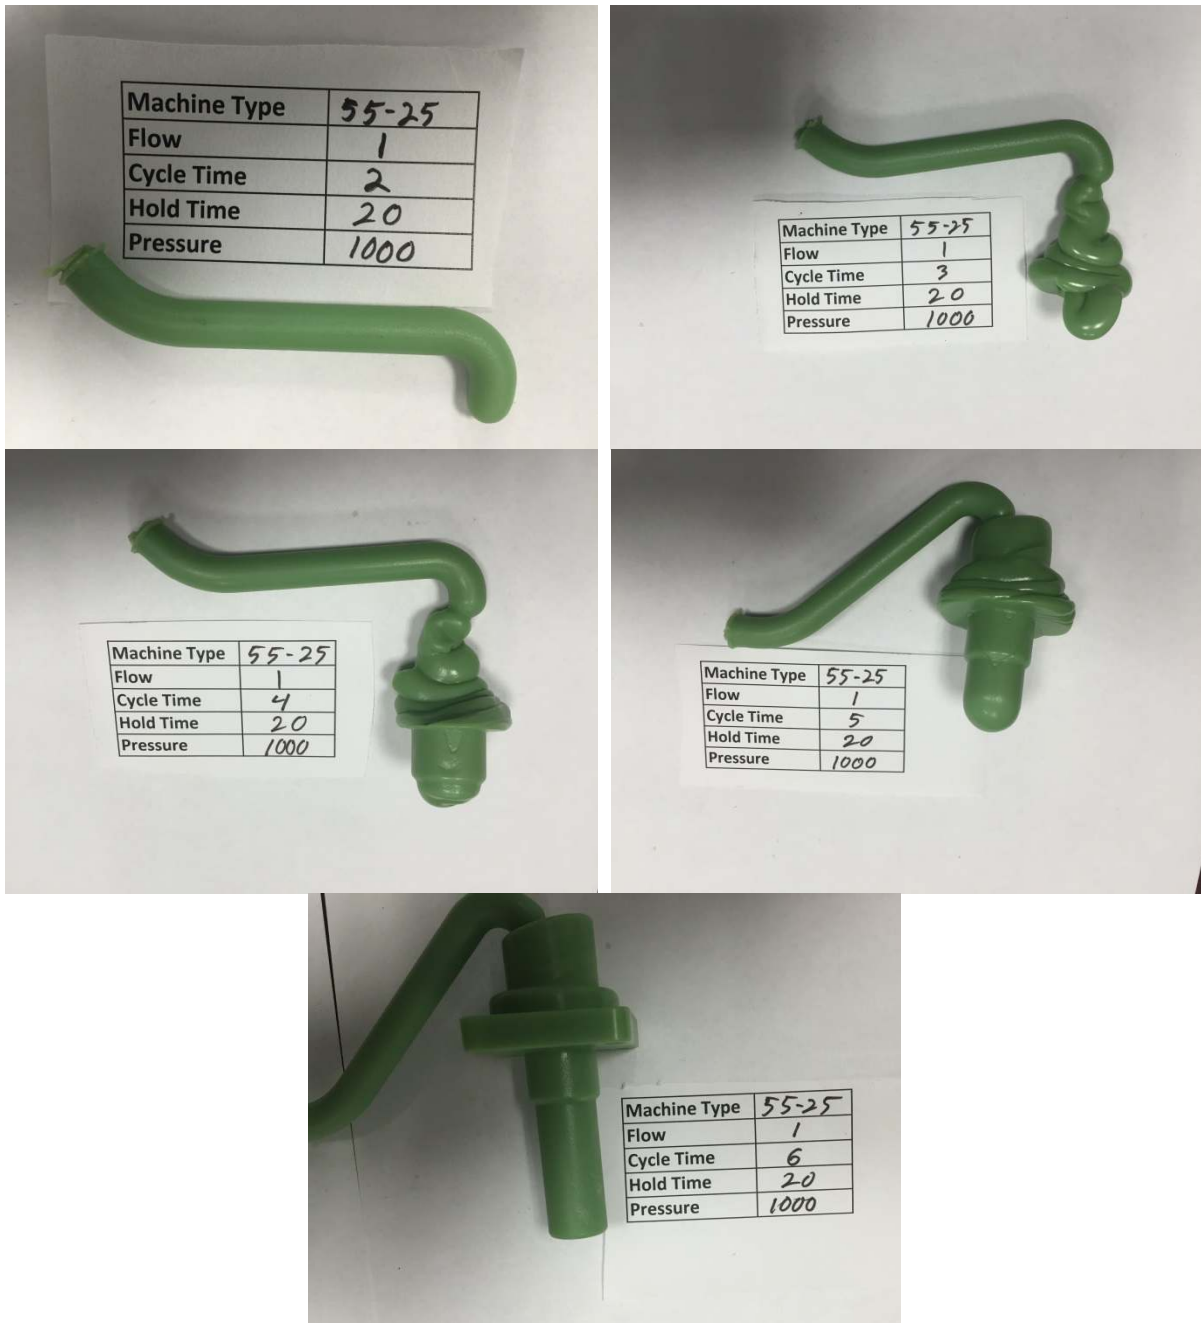
Figure 6: Sample of Short Shot picture Series

It was determined the best method to find the anomaly that was causing the entrapped air would be to use a series of short shots. Short shots are partial injections, where the injection process is started and then stopped at a set time interval prior to the completion of the filling of the cavity. Short shots completed at various time intervals allow a view of how the wax is entering and filling the cavity. With several short shots completed at different set times a complete picture of the cavity fill is obtained for analysis. Required process changes and/or die changes may be more apparent with this information.

Careful examination of the short shot pictures combined with an understanding of the geometry of the die cavity and specifically the injection runner led to a conclusion. The short shots showed us that the wax entered the die cavity from the injection runner and filled the cavity like a stream of spaghetti. Flowing in this manner the cavity allowed the wax to fold over itself inside the die. This folding allowed air to be entrapped between wax folds. The entrapped air in many instances was completely surrounded by wax. In those instances, the part may prove to be acceptable as no surface defects occurred. In parts where the entrapped air was very near or at the surface of the wax, the part was defective.

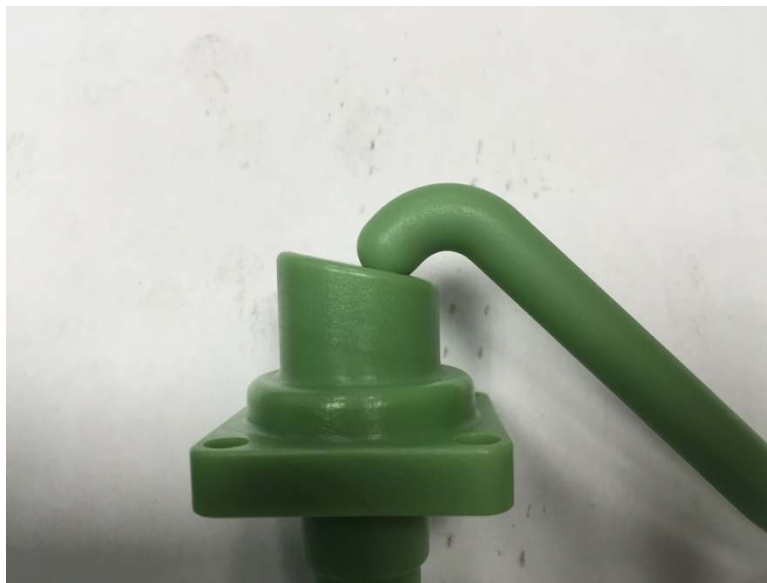
Figure 7: Picture of runner necked down

The die was examined to see if any possible causes could be determined for this effect. The injection runner with a diameter of  $\frac{3}{8}$  inch was necked down to  $\frac{1}{4}$  inch just prior to entering the die cavity. The necked down portion of the runner is visible in the die picture figure 1. Figure 7 shows more clearly the resulting pattern from the necked down runner. It was hypothesized that this minor change in the wax's flow path was contributing to the observed condition causing the high defect rate. It is common practice to neck down a runner or gate to allow for easier separation of the runner and/or gate in either wax or metal. That practice may contribute to

defective patterns as the wax flow through the necked down portion becomes more turbulent. The decision was made to remove the material in the necked down area allowing the wax a more laminar flow from the runner entering the wax cavity. After the die modification, further testing would be required to observe the results of this change.

The first order of business was to make the needed die modifications. The changes can be seen in figure 9 by looking closely at the point where the runner enters the main die cavity. Compare die figures 1 and 9. The effect of the modification can also be seen by comparing the same area in the pattern, see figure 7 and the last picture in figure 10 for comparison.

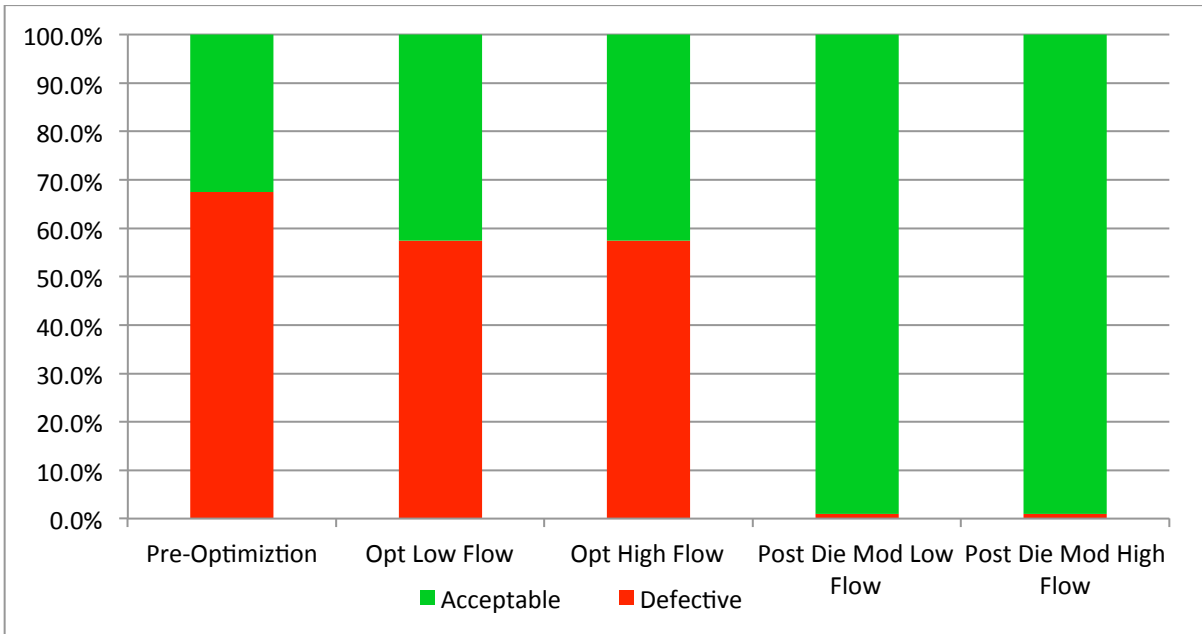
Figure 11: Defect Rate - Pre-optimization, optimized and post die-modification

Overall defect rate was reduced from 67.5% (pre-optimization) down to 1% with the optimized recipe run on the die after modification. This represents a 440% improvement (or otherwise stated a 98.52% decrease) in defect rate. This also resulted in a significant improvement in cycle time per batch
