**Technical Paper**

**Current Problems In The Wax Room And How They Are  
Best Overcome**

**Presented during the 62<sup>nd</sup> ICI Technical Conference & Equipment Expo  
October 21, 2015**

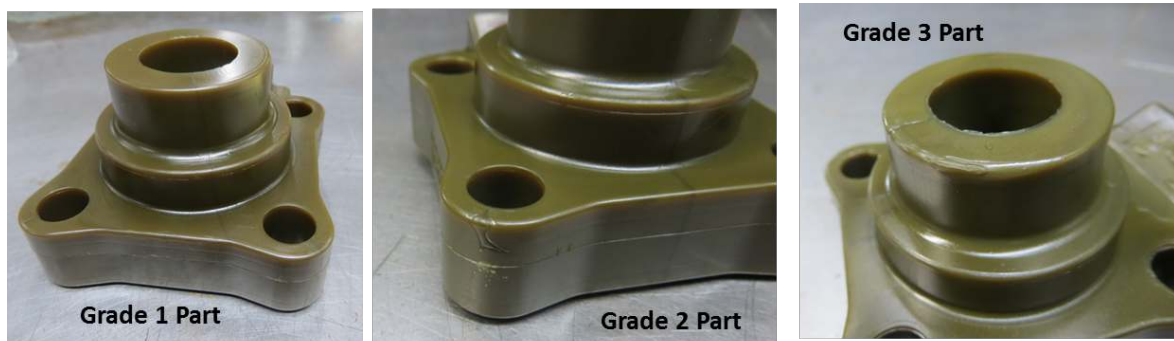
*Figure 3: Die 1 Pattern Grading*

Examples of die 1 pattern grading are shown in figure 3. Typical grade 2 indications consist of knit lines around the outer holes of the pattern. Grade 3 indication were more severe in nature and consisted of significant flow lines throughout the pattern.

Pattern quality was graded using the same inspector for all runs in the experiment. The inspector graded each pattern looking at flow lines, air entrapment and general visual pattern quality. A pattern was given a value of 1 if the pattern was deemed acceptable for the

subsequent process. A value of 2 was assigned if the injection was usable but required repair. Finally, if the pattern was deemed unusable or scrap the pattern was given a value of 3.

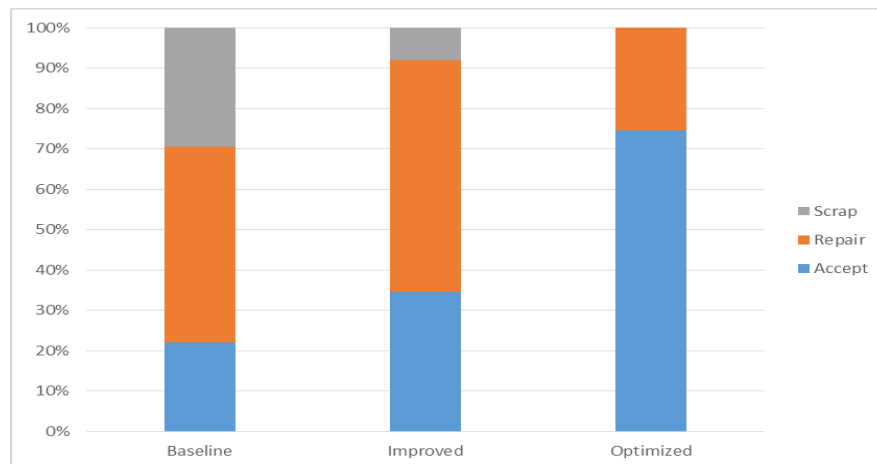
*Figure 7: Die 1 Pattern Quality*

Viewing figure 6 illustrates the effect of the wax parameters and machine capability on the quality of the injected patterns. Scrap rates reduced from a baseline of 30% to 8.5% at the improved parameters. The optimized parameters removed all scrap observations from the sample set. Even better, the yield rate of good parts requiring no rework went from 22% to 35% to 75% when comparing baseline, improved and optimized runs respectively.

The scrap and rework reduction is significant in itself, but while doing this we initially increased cycle time for the improved injections on Machine 1. However, with a fully functioning, high process control Machine 3 we cut the cycle time by 42.2% over the improved injections and 33.3% over the baseline injections. An unforeseen element of this improved cycle time was an elevated throughput of wax exceeding the cooling capability of the chiller connected to the conditioning reservoir. This manifested itself in wax injection temperature gradually increasing as is seen in the Machine 3 Mini-tab Quality Six Pack chart for temperature between injections later in this paper. This special cause variation was tracked down to the root cause, which was insufficient chilled water flow.

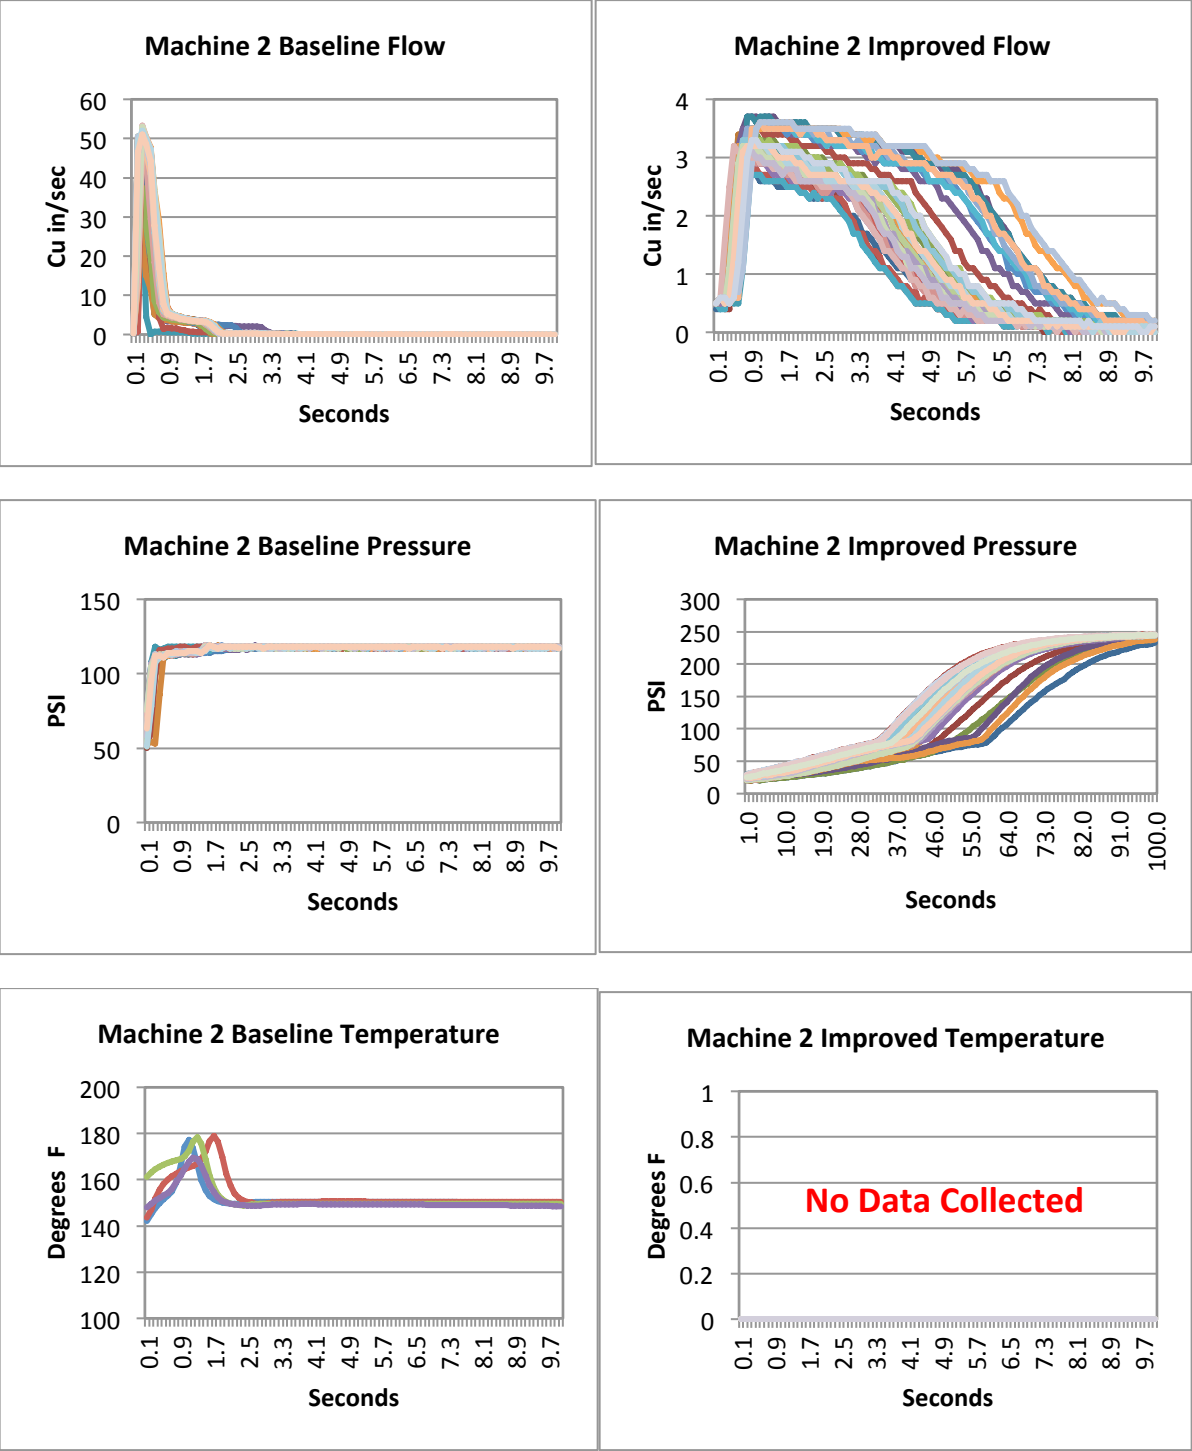
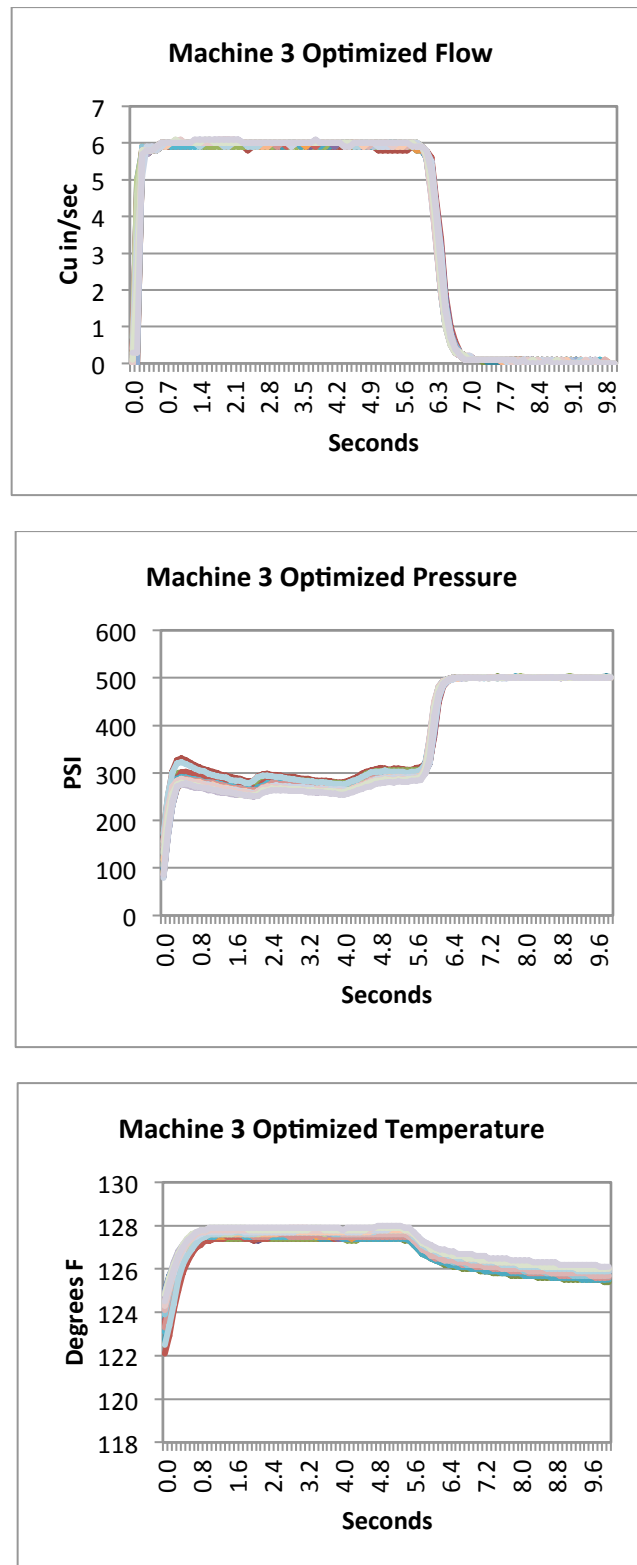
The following graphs represent the data collected using the portable injection graphing unit from each injection by machine.
