**Technical Paper**

**Current Problems In The Wax Room And How They Are  
Best Overcome**

**Presented during the 62<sup>nd</sup> ICI Technical Conference & Equipment Expo  
October 21, 2015**

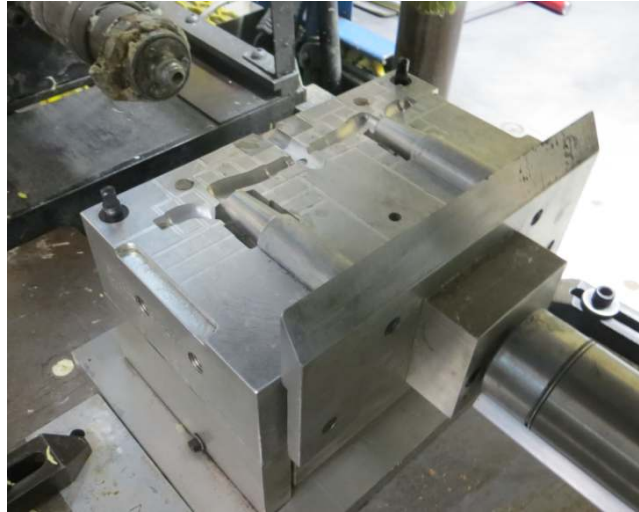
The die on machine 2 was a two-cavity tool with one manually actuated pneumatic slide and manually actuated ejection. The defect noted on these parts was poor surface finish.

*Figure 4: Die 2 Configuration*

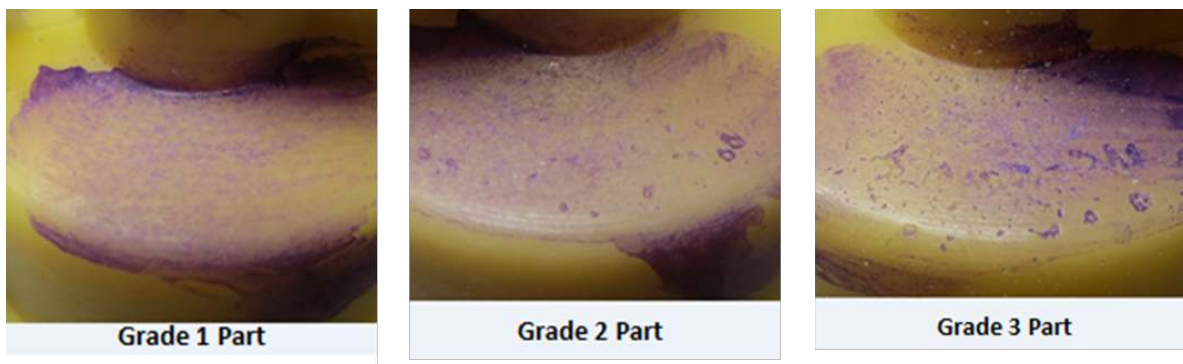
As previously described for Die 1, the experiment was conducted on Die 2 per the experiment plan. Die 2 was set up according to the original die recipe and the 40 initial injections were produced. Per the experiment plan, the patterns were evaluated and the injection data collected on the injection graphing unit. The primary defect for this part was surface finish blemishes in the form of surface negatives. A blue dye was applied to the soluble patterns after injection to aid in visual detection of the negatives. Examples of die 2 pattern grading are shown in figure 5.

*Figure 5: Die 2 Pattern Grading*
