**Current Problems In The Wax Room And How They Are
Best Overcome**

**Presented during the 62nd ICI Technical Conference & Equipment Expo
October 21, 2015**

**Jeffrey Rich
MPI, Inc.**

**Andrew Miller
Tech Cast, LLC**

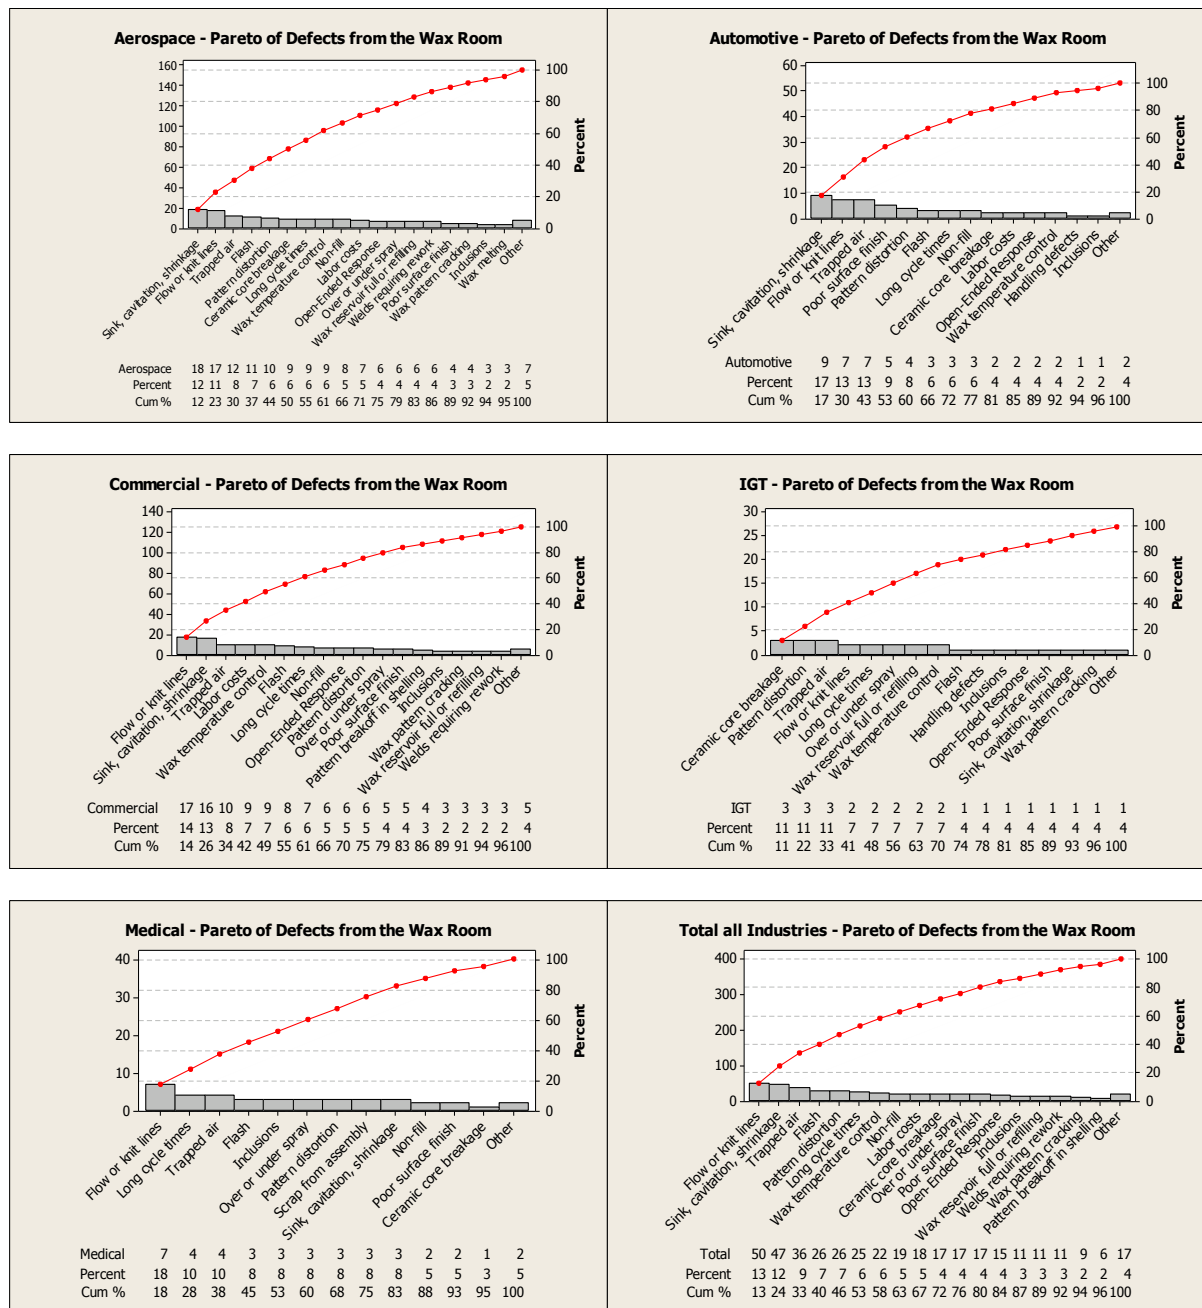
Minor differences by industry were observed and below, in figure 1, are Pareto charts illustrating the various defects noted by the foundries. Each foundry was specifically asked, "What are the top 5 problems that you are facing in your wax room that you wish you had a solution for TODAY?" A checklist of 22 known issues was provided along with a space to write in any comments. The data was collated to determine the most prevalent issues.

Figure 1: Industry Survey Results

A web-based survey was conducted asking foundries to provide a listing of their top wax-room issues. Sixty-five foundries responded to the survey providing insight into their respective problem areas and the defects most experienced. While the survey provided no surprises, it was important to validate wax-room issues directly from the foundries actual experiences. The results, as shown in figure 1, were in line with what we had anticipated they would be. Overall, the top three issues were related to:

- 1) Flow or knit lines
- 2) Sink, Cavitation, Shrinkage
- 3) Trapped Air

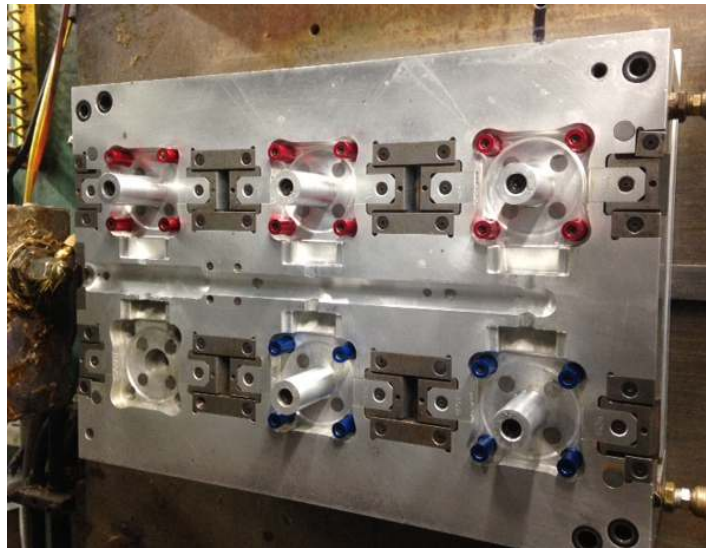
Die 1 was a six-cavity tool, shown in figure 2, where one cavity is blocked off due to inability to produce good parts when all six cavities are used. The tool reportedly produces high scrap rates due to flow lines, knit lines and air representing two of the top defects from the survey.

Figure 2: Die 1 Configuration

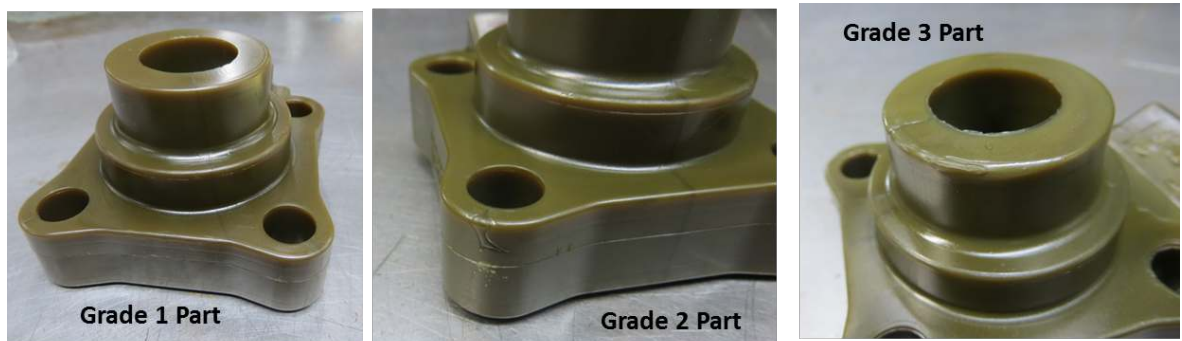
Examples of die 1 pattern grading are shown in figure 3. Typical grade 2 indications consist of knit lines around the outer holes of the pattern. Grade 3 indication were more severe in nature and consisted of significant flow lines throughout the pattern.

Figure 3: Die 1 Pattern Grading

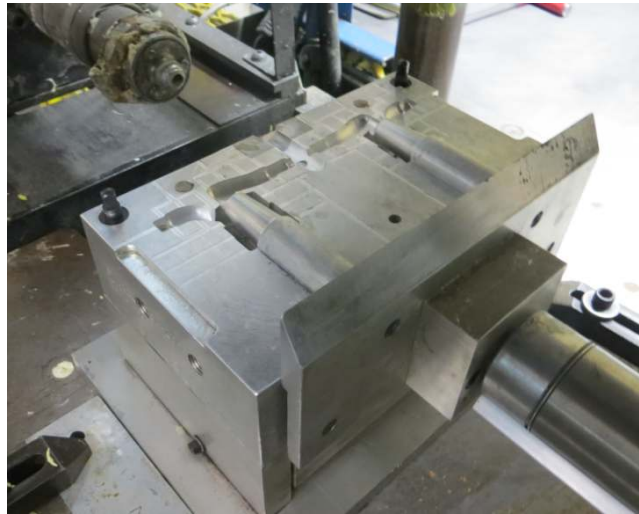
The die on machine 2 was a two-cavity tool with one manually actuated pneumatic slide and manually actuated ejection. The defect noted on these parts was poor surface finish.

Figure 4: Die 2 Configuration

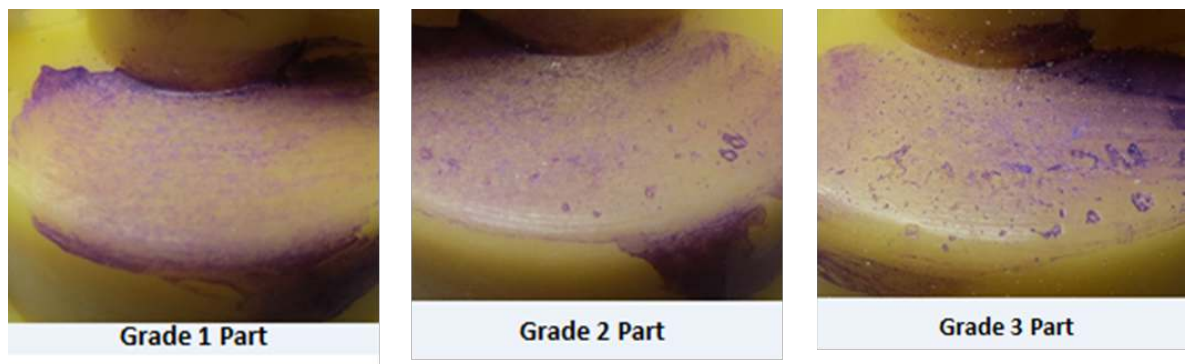
As previously described for Die 1, the experiment was conducted on Die 2 per the experiment plan. Die 2 was set up according to the original die recipe and the 40 initial injections were produced. Per the experiment plan, the patterns were evaluated and the injection data collected on the injection graphing unit. The primary defect for this part was surface finish blemishes in the form of surface negatives. A blue dye was applied to the soluble patterns after injection to aid in visual detection of the negatives. Examples of die 2 pattern grading are shown in figure 5.

Figure 5: Die 2 Pattern Grading

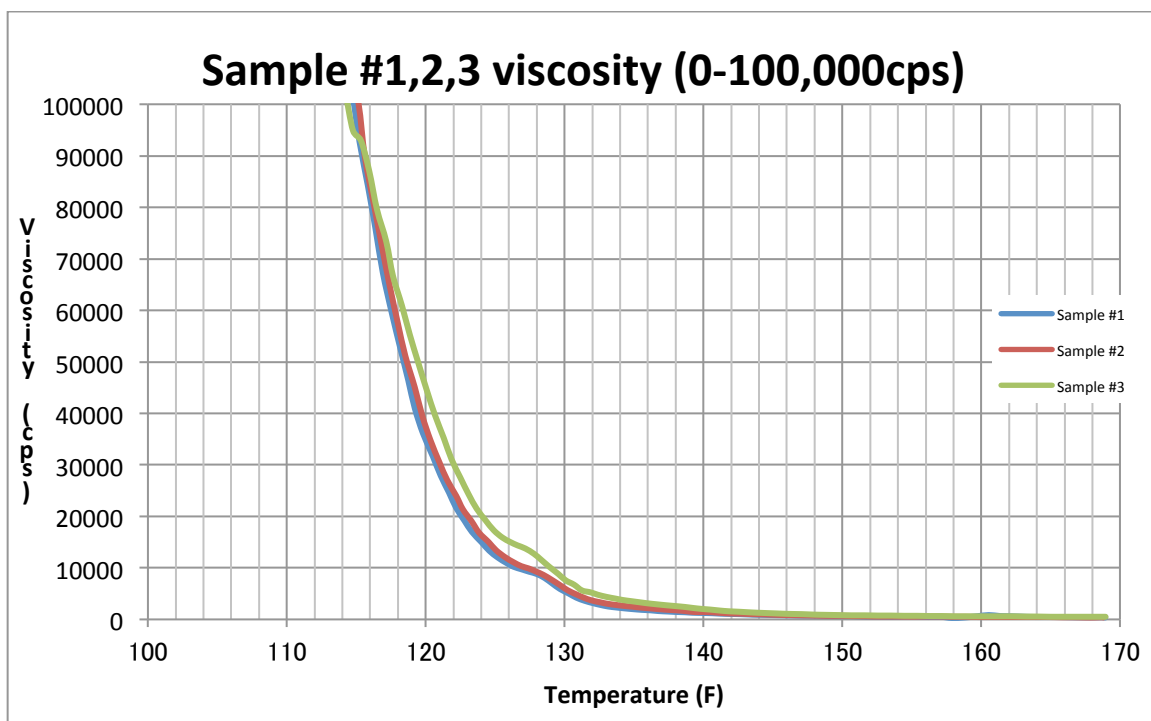
It has been established from previous experimentation that batch to batch variability can have a significant effect on pattern quality as the characteristics of the wax drift within the manufacturer's tolerances. To eliminate that variable, wax from three different batches was sent out for viscosity testing. Below are the viscosity curves for all three samples. Based on the similarities among the curves the batch to batch viscosity variation was deemed acceptable for the purposes of the experiment. To further reduce variation, the foundry provided the alternate test facility with wax from the same vintage as tested on Machine 1.

Figure 6: Wax Viscosity Curve

The wax was conditioned and the minimum injectable temperature was determined to be 126 degrees. The wax reservoir was continuously fed newly melted wax via an on-machine wax melter relying on the reservoir level control to keep the conditioning reservoir at the optimal level, always near full.

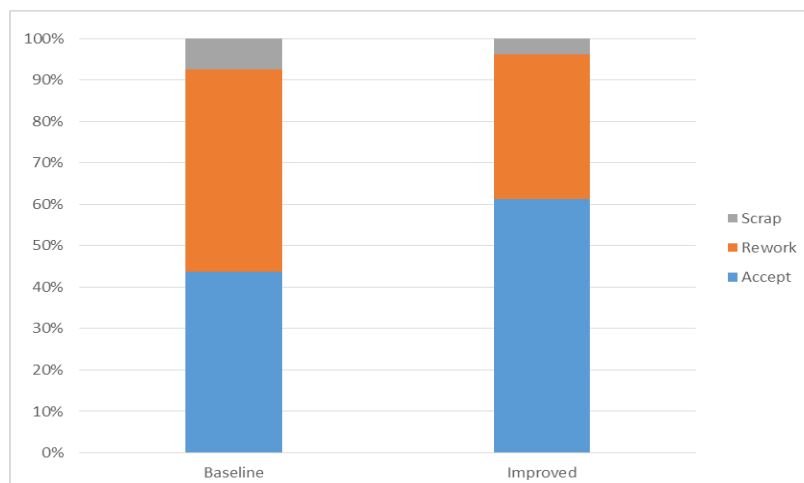
Regarding Die 2 on Machine 2, the minor changes made to this recipe we did see an improvement in the parts which netted scrap reduction from 8% to 4% and a yield rate increase of good parts (no rework required) from 44% to 61%.

Figure 8: Die 2 Pattern Quality

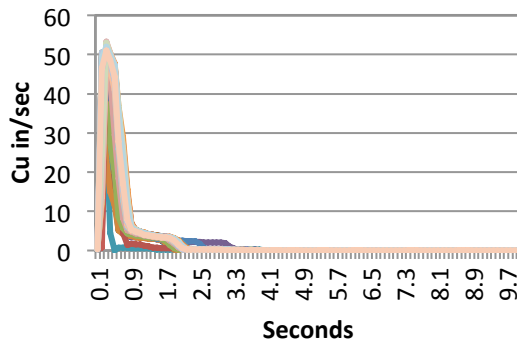
**Machine 2 Improved Flow**

The wax flow was controlled by a needle valve. The baseline setting was maximum flow with a black ring visible on the needle valve screw. It was quickly determined that the injection parameters had the machine in pressure control. Injection machine manufacturers recommend using flow control. The difference is understanding how the flow rate is being controlled. Pressure is a tool to do two things: achieve the desired flow and to pack the die after the die is full. Flow control is achieved when the pressure is sufficient to obtain the desired flow rate set on the machine. The correct method is to adjust the flow rate to the desired flow and ensure the pressure is sufficient to achieve that flow rate. This can be verified on a manual machine by nozzle purging and increasing pressure while purging. If the flow rate increases as pressure is increased, the machine is in pressure control. For the optimization of this part, we wanted to ensure the machine was operating in flow control. As such, the flow rate was decreased to a setting that allowed for flow control.

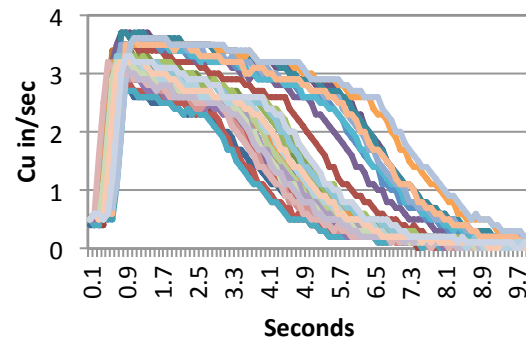
**Machine 2 Baseline Pressure**

Wax pressure was initially set to 120 psi. Again, to ensure we had sufficient pressure to put the machine into flow control as well as increase the packing out of the part, we set the machine to 250 psi.

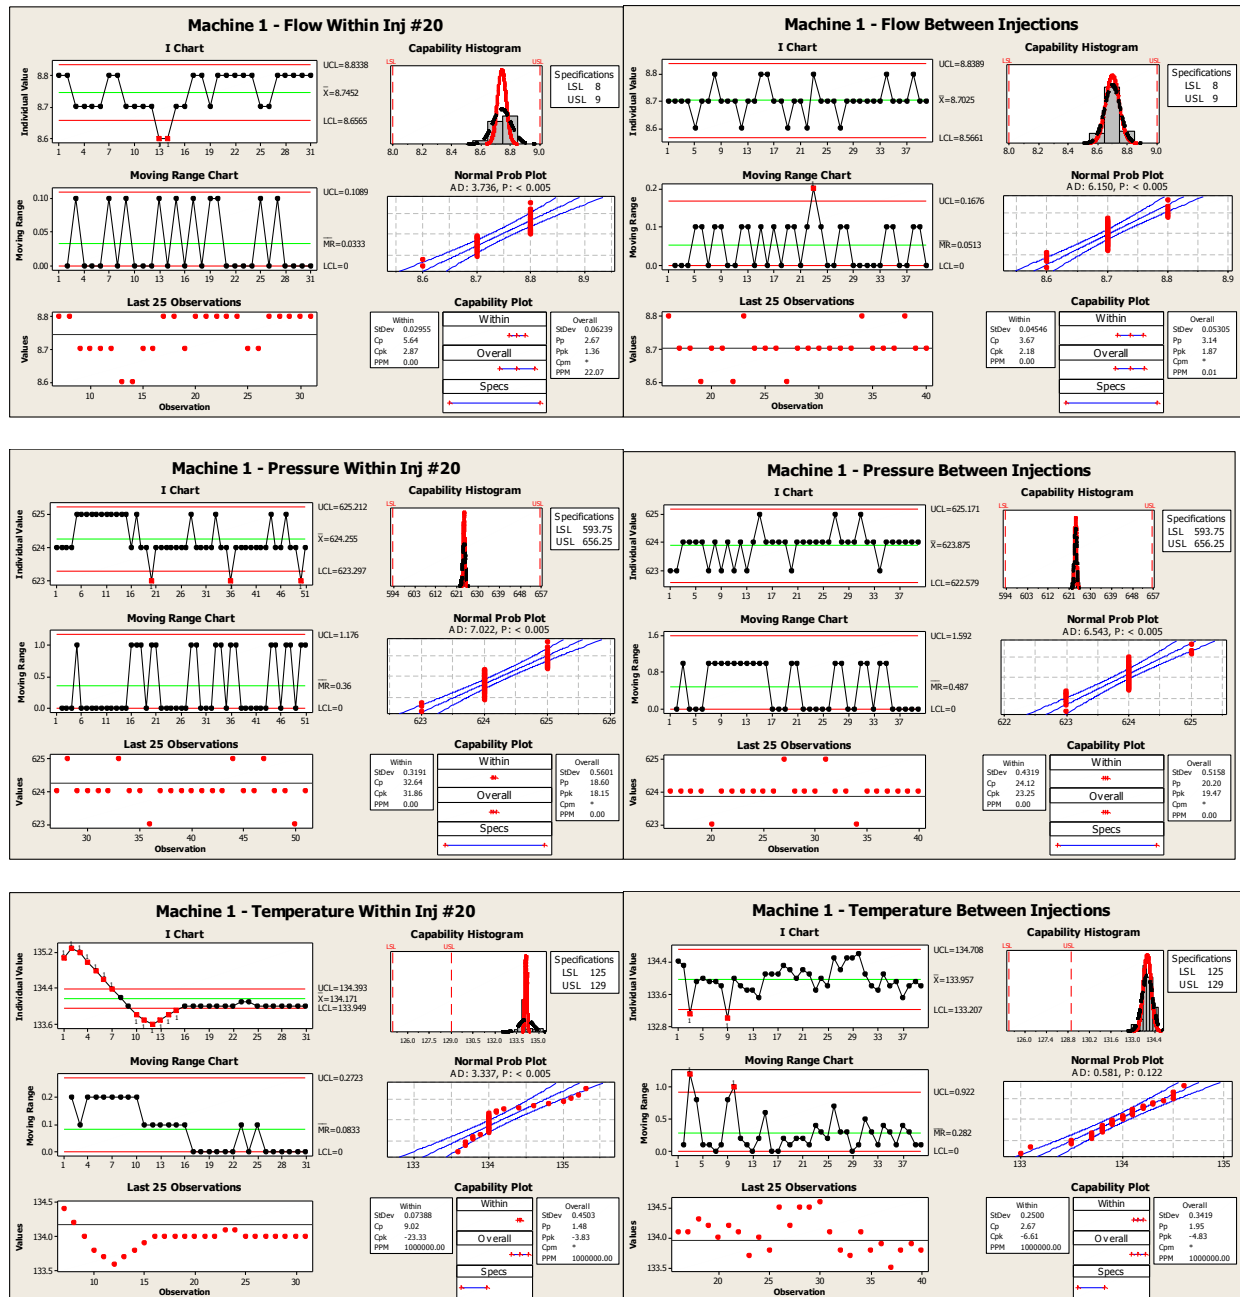
Machine 1:

using Mini-tab's Quality Six-Pack tool. One set of graphs is used to look at capability within a single injection, while another set of graphs is used to compare one injection to the next covering all 40 injections. Each metric is analyzed during a part of the injection cycle when the process should be controlled by the machine set point. As an example, within an injection on Machine 1, flow is analyzed while the wax is flowing from 1 second to 3.5 seconds, temperature is analyzed in the same time period and wax pressure is looked at after the flow stops and the die is packing. For all analysis within an injection, we chose to use injection number 20 data. To analyze from one injection to the next an appropriate point in the injection was selected where for each criterion the machine should be providing the same output. For example, when comparing the flow for machine 1 between all injections we used the data recorded by the injection graphing unit at 2 seconds, temperature was looked at for the same time and pressure was analyzed at 9.9 seconds. There are six, Six-Pack charts for each machine. One set of three dedicated to within an injection for temperature, pressure and flow and another set of three for between injections for the same criterion. The set point was used as the target value for each criterion and where no set point is easily discernable (i.e. manually set control with no feedback) the actual mean as produced and recorded by the injection graphing unit is used. The specification limits are established as plus or minus two degrees F for temperature, 5% for pressure and .5 in³/sec for flow.

Analyzing this data tells us if the machine is statistically capable. Statistical capability includes determination of three questions: is the machine in control, is the machine stable and is the machine capable? To analyze the first two questions we review the results of Statistical Process Control (SPC) charts. To answer the third question we use standard capability matrices Cp and Cpk. This information is located on the below Mini-tab Quality Six-Pack charts.

Capability Analysis								
		Within Injection #20				Between Injections		
		Flow	Pressure	Temp		Flow	Pressure	Temp
In Control?	Machine 1	* Yes	Yes	No		Yes	Yes	* Yes
Stable?		Yes	Yes	Yes		* Yes	Yes	* Yes
Capable?		Yes	Yes	No		Yes	Yes	No
In Control?	Machine 2	No	No	No		Yes	* Yes	Yes
Stable?		* Yes	* Yes	No		Yes	* Yes	Yes
Capable?		Yes	Yes	No		No	Yes	No
In Control?	Machine 3	* Yes	Yes	* Yes		* Yes	Yes	** Yes
Stable?		* Yes	* Yes	* Yes		Yes	Yes	Yes
Capable?		Yes	Yes	Yes		Yes	Yes	Yes
* Items indicate some special cause variation that when reviewed is insignificant								
** Special Cause Variation due to external problem - Chiller flow not adequate for demand
