Technical Paper

Overcoming Common Wax Injection Problems: The First Step toward Automation

Aaron Phipps
VP of Sales and Marketing
Technology Center Manager
MPI, Inc.

Jeffrey Rich
VP of Operations
MPI, Inc.

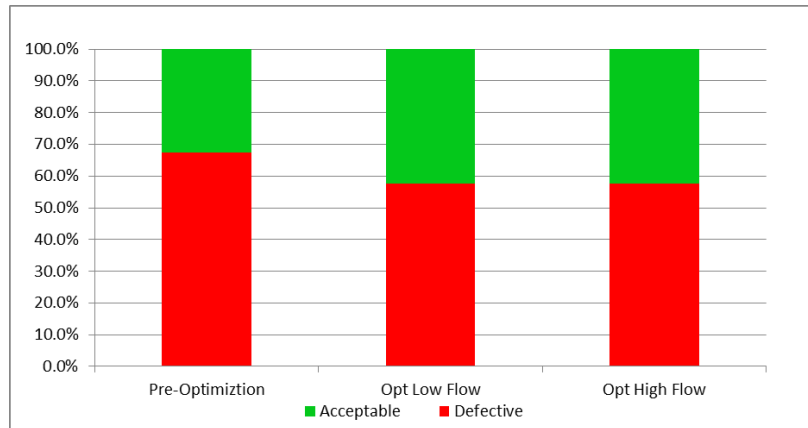
Figure 4: Defect Rate - Pre-optimization and optimized

Overall defect rate was reduced from 67.5% (pre-optimization) down to 1% with the optimized recipe run on the die after modification. This represents a 440% improvement (or otherwise stated a 98.52% decrease) in defect rate. This also resulted in a significant improvement in cycle time per batch

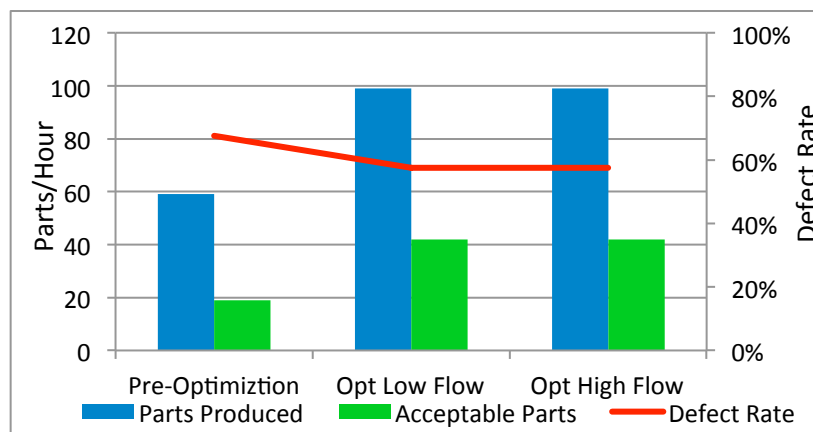
Figure 5: Parts produced per hour Pre-optimization and optimized

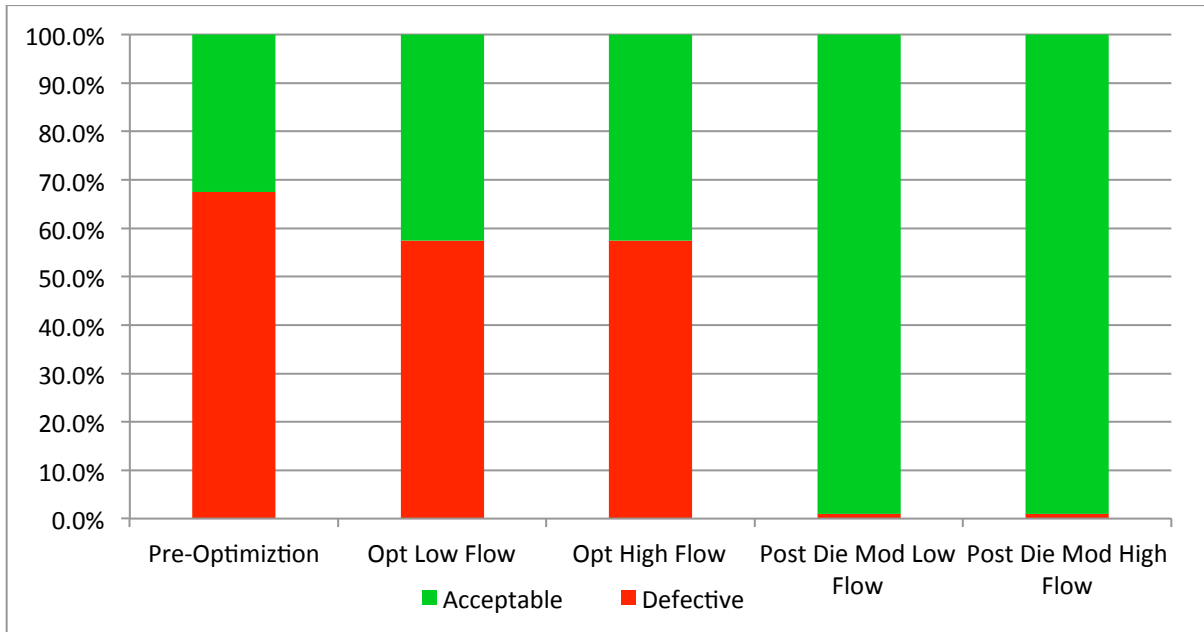
Figure 11: Defect Rate – Pre-optimization, optimized and post die-modification

defective patterns as the wax flow through the necked down portion becomes more turbulent. The decision was made to remove the material in the necked down area allowing the wax a more laminar flow from the runner entering the wax cavity. After the die modification, further testing would be required to observe the results of this change.

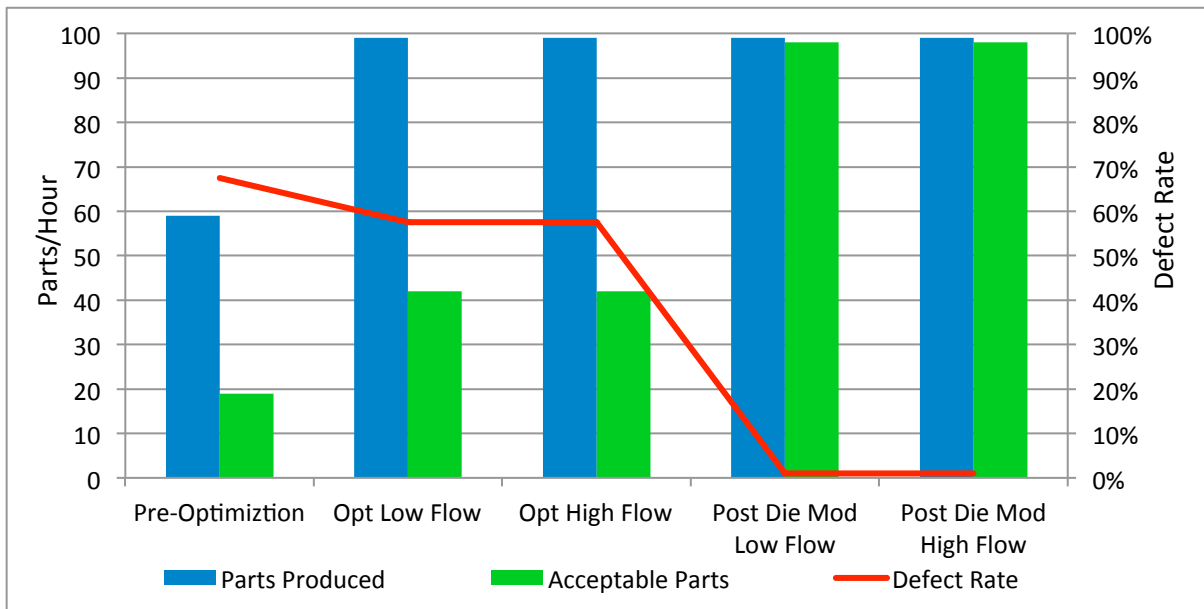
Figure 12: Parts produced per hour Pre-optimization and optimized
